Analysis of Bank Erosion on the Merced River, Yosemite Valley, Yosemite National Park, California, USA

MARY ANN MADEJ*
WILLIAM E. WEAVER¹
DANNY K. HAGANS¹

Redwood National Park
1125 16th Street
Arcata, California 95521, USA

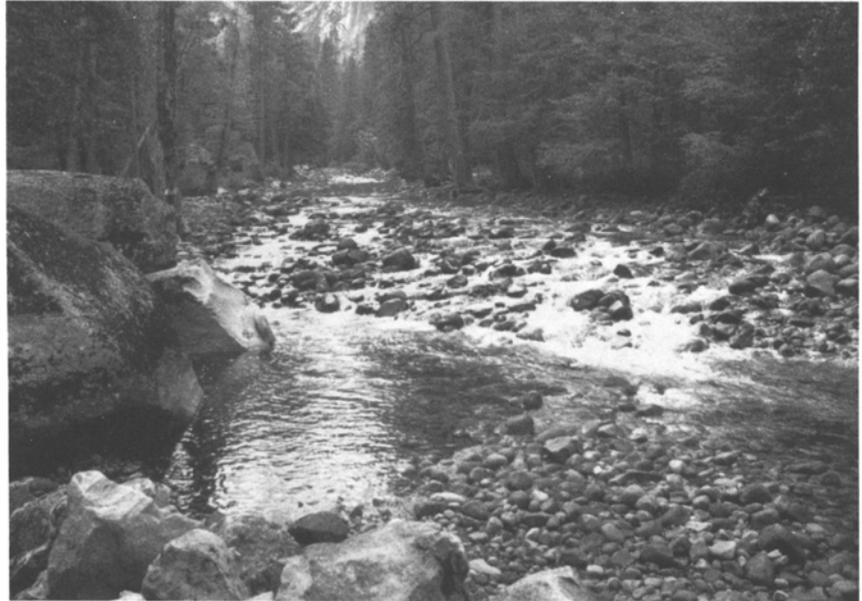
Figure 2. The Merced River downstream of Happy Isles Bridge exhibits a steep, coarse channel bed and bouldery, well-vegetated banks.

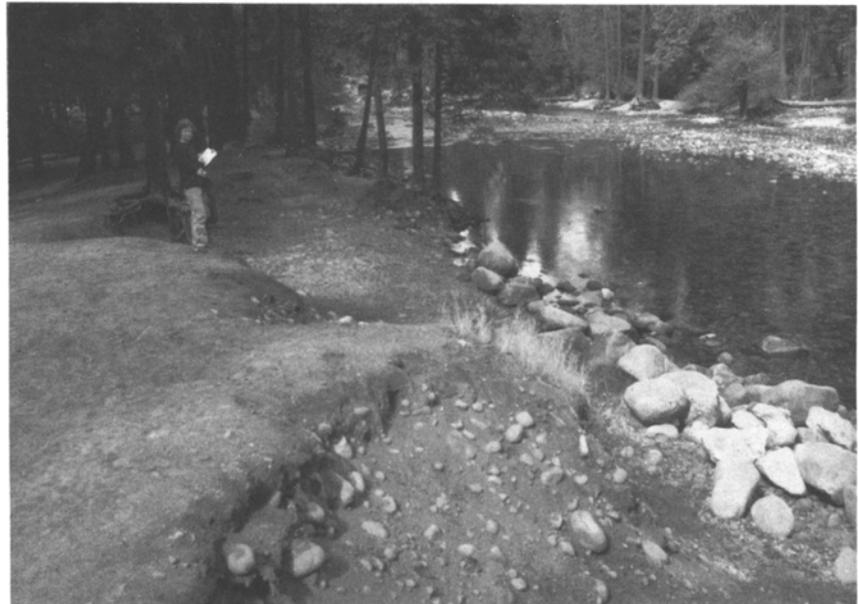
Figure 3. Looking downstream at the Merced River near Clarks Bridge. Erosion is occurring on the left bank both behind low rip-rap and in areas without channel revetment. Riparian vegetation is sparse, the floodplain has little organic litter or ground cover, and the soil is compacted.

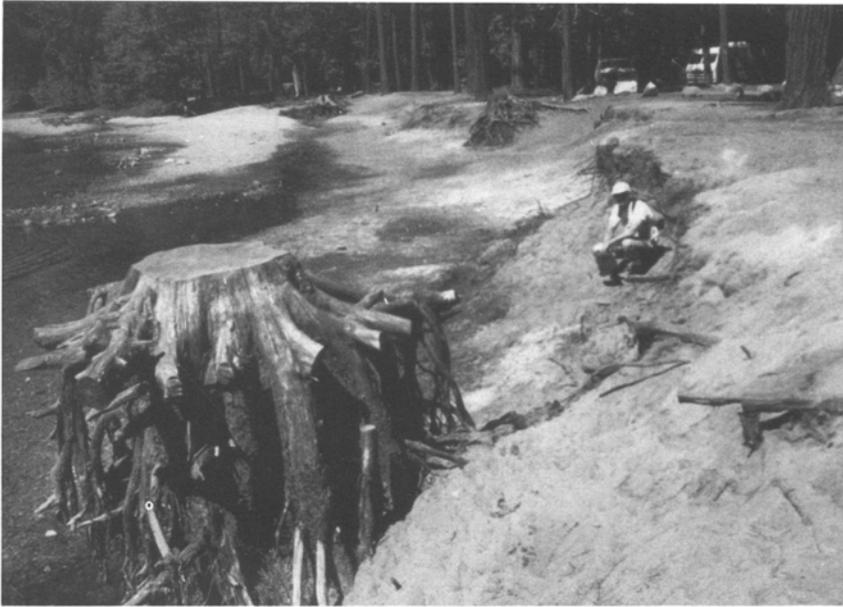
Figure 4. Erosion of left bank in the upper study reach. Fine-grained unvegetated banks have eroded, leaving stumps of former streamside trees within the present active channel.

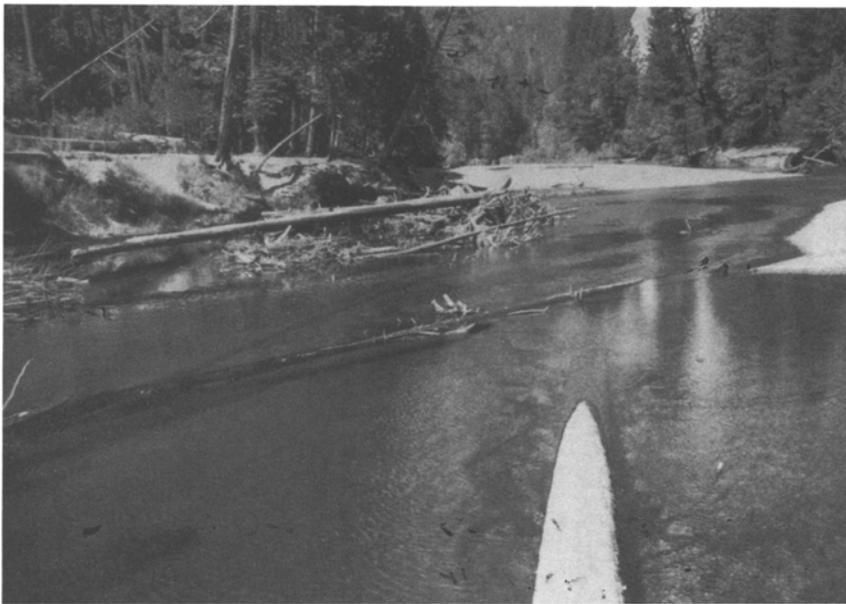
local areas on the river, but to a much lesser degree than in the upper reach. Riparian vegetation is denser and woody debris is more abundant in the downstream reach (Figure 5).

Figure 5. View looking downstream at the lower study reach showing abundant woody debris lying both on streambanks and in the active channel.

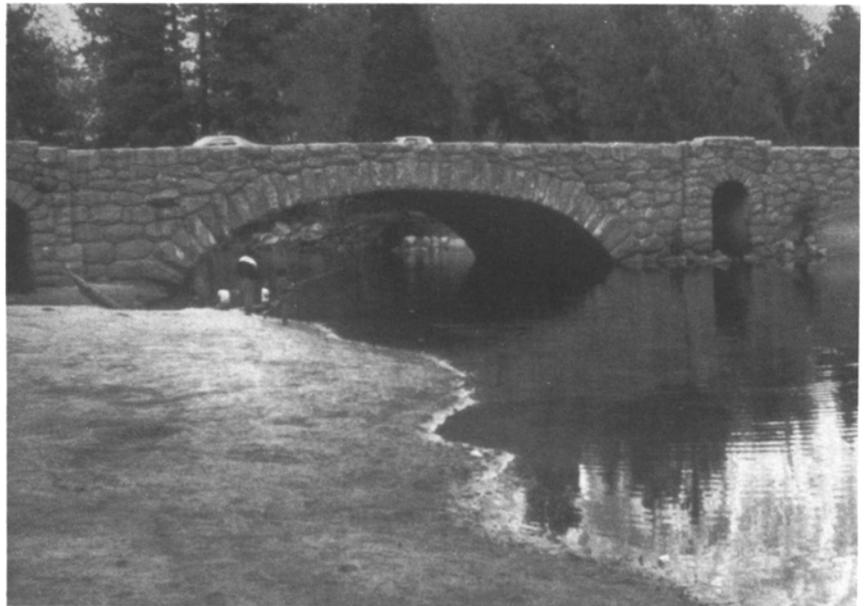
Several foot and vehicle bridges cross the Merced River in Yosemite Valley. Many of these bridges are decades old, and eight are listed on the National Register of Historic Places. In a natural river channel, the streambanks are either vertical or sloping back away from the stream, so that as flows increase, channel width and cross-sectional area also increase. However, the situation is reversed at many bridges on the Merced River. The arched bridges confine the flow, and actually produce a narrower channel at higher flows (Figure 12). Six bridges in the upper reach are an average of 38% narrower than the unconstrained channel immediately upstream of them (Milestone 1978). Bridge constriction causes several problems. First, flow velocity increases at the constriction, resulting in scour at the bridges. Deep scour holes and scour around bridge abutments were both evident at bridges with constrictions. Second, if all flow cannot be conveyed under the bridge at high discharge, water can become backed up behind the bridge. Low-lying areas or overflow channels can become flooded by the backwater. The release of backwater through overflow channels has caused locally severe erosion problems in Yosemite Valley. One overflow channel, at Sugarpine Bridge, widened from 4 to 17 m since 1919, and presently threatens roads, campsites, and the bridge itself. Sediment scoured from bridge sites was deposited in mid-channel bars downstream of the bridges, and streamflow was directed against the streambanks, causing widespread erosion.

Figure 12. View looking upstream at Stoneman Bridge showing arched design and bridge abutments in active channel, both of which constrict flow at high discharges. Channel widening has caused walkways at side to presently be within active channel.

Several possible actions to reduce future human-caused damage may be considered. Where bridges constrict flow, they cause localized erosion and should be replaced or removed. Where channel armor is nonfunctional or causing streambank erosion, it should be removed and banks need to be aggressively replanted. Biotechnical bank protection devices may be used in critical areas to provide a base for revegetation. Visitor access to the river should be focused onto point bars and pedestrian foot traffic should be ac-

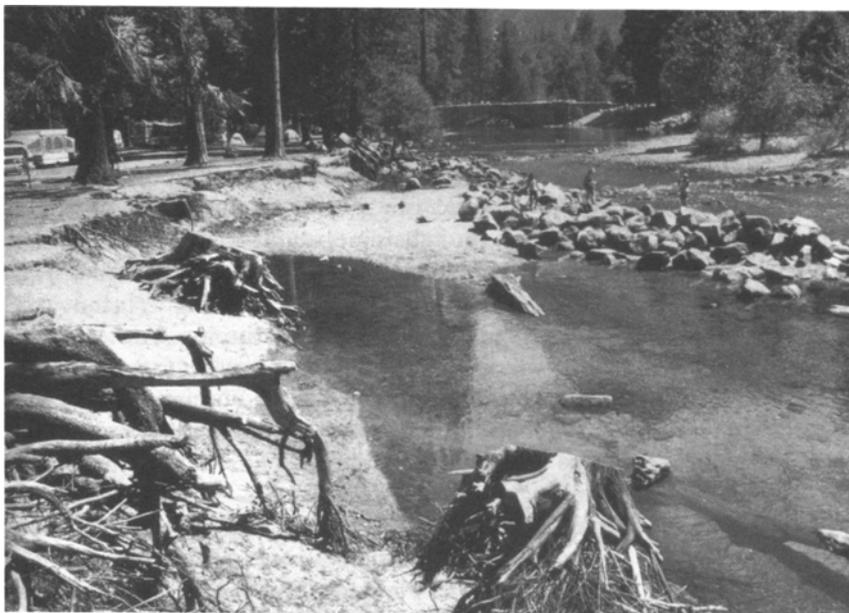
Figure 13. View upstream of Merced River in the upper study reach. Right bank has eroded 25 m since 1919, and riprap formerly on the bank is now in mid-channel. Trees undercut by bank erosion were cut down to reduce threats to visitors, leaving stumps in channel.

The presence of revetment is common along the banks of the Merced River and some of its tributaries. Installation of revetment reached its peak during the 1930s and reflects many different methods. It varies from small (20 cm) hand-placed rocks to large (60- to 100-cm) boulders dumped along the bank by heavy equipment. If well designed, channel revetments can protect streambanks; however, poorly designed structures caused localized scour and lateral erosion in several locations in the upper study reach (Figure 13).
