Electrical Leak Detection System for Landfill Liners: A Case History

by C.C. White and R.D. Barker

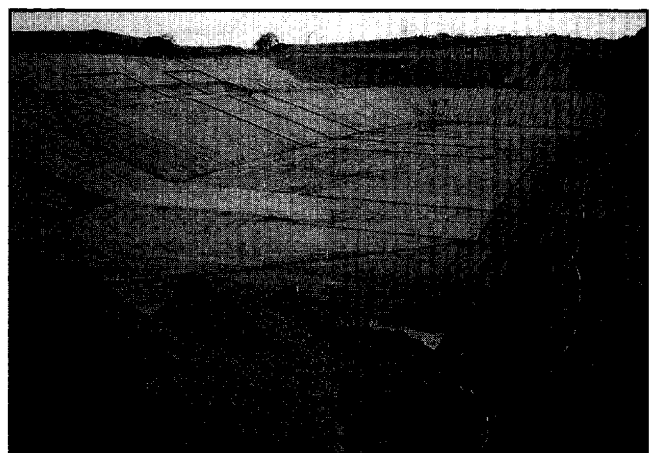
Photo 1. Shallow trench lines for the geophysical cables map out the position of the grid during landfill.

The leak detection system comprises a grid of electrodes installed just beneath the two liners, providing full coverage across the base and up the sides of the landfill (see Photo 1). The main components of the system are shown as a section in Figure 1 and in plan in Figure 3. A spacing of 20 m for the basic grid of electrodes was chosen after simple mathematical modeling studies and from the results of tests made using a small-scale 5-m-square model landfill built at the quarry site. These tests showed that it was difficult to estimate the actual size of hole that could be detected. Since the system installation, however, its sensitivity is being established in some detail.

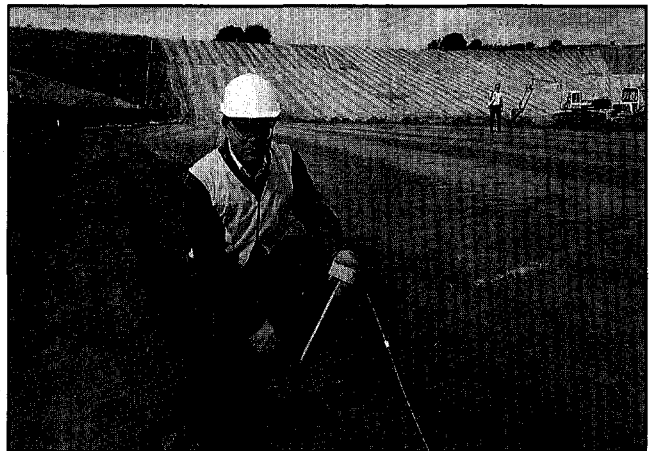
Photo 2. Electrode and geophysical cable installation.

Each electrode is constructed from 316 stainless steel (Photo 2) and connected to one of a series of multicore cables which are laid from the landfill to control equipment located in the weighbridge (Figure 3), where measurements can be taken remotely using a portable computer and a Campus Geopulse earth resistance meter. The system records the distribution of voltage beneath the landfill, normalized by dividing by the transmitted current. Although this yields units of resistance, this has little physical meaning, and it is more useful in this case to consider it is a voltage distribution per unit transmitted current.

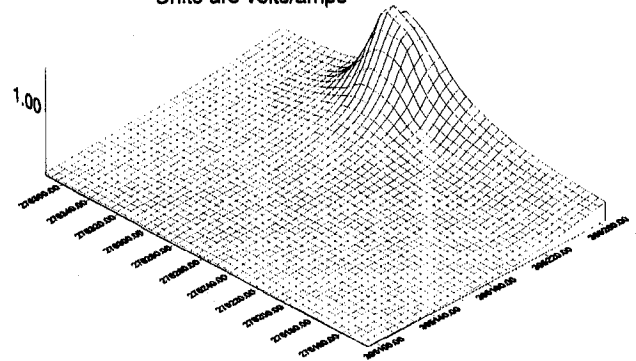
Figure 5. Liner integrity test showing effect of the access ramp.

The first test of the monitoring system was to check the integrity of the FML liner immediately after completion of the sand protection layer. Initial measurements showed the system to be extremely sensitive with current flowing over the edges of the FML liner where the sand protection layer was in contact with the surrounding ground. For example, the access road for lorries into and off the landfill had to be severed temporarily during testing as all the current flowed out through the sand protection layer from Cell 1 via this route, producing a major anomaly (Figure 5). The causes of such high anomalies were removed in order to ensure that false negatives caused by the masking of smaller anom-

alies representing holes did not occur. Modifications to the access road have since been made to eliminate this problem. It was even observed that a sand bag, temporarily weighing down the edge of the FML but bridging and making contact with the surrounding ground would result in a detectable anomaly.

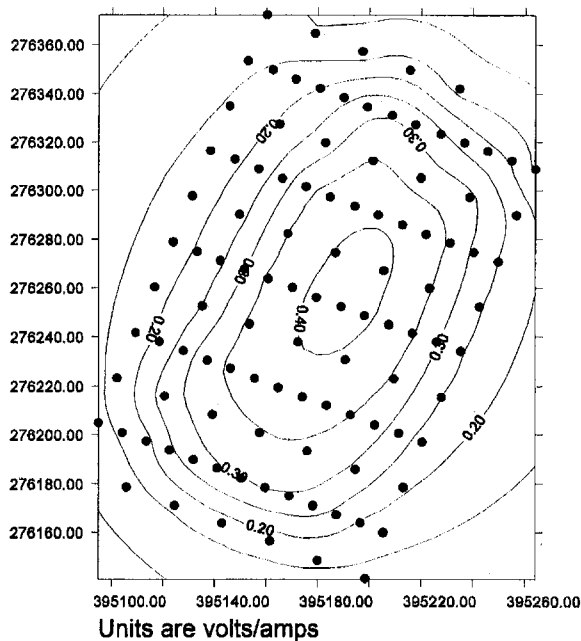
Figure 9. Integrity test results with no holes present.

The pattern of measured potential difference that relates to an FML liner with no holes is shown in Figure 9. The resulting broad anomaly across the landfill is a capacitance effect from the FML material itself

brought about through use of a low-frequency alternating current during measurement.

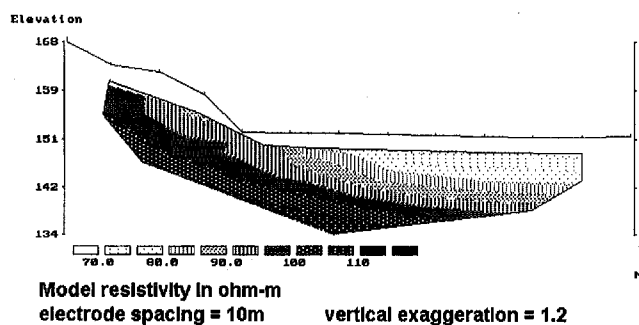
Figure 11. East-west resistivity section beneath the landfill.

Resistivity images can also be produced along any line of electrodes within the grid. One such image is illustrated in Figure 11, which has been produced using a Wenner electrode arrangement and a data collection method described by Griffiths and Barker (1993). Comparison of future images with background data presently being collected will again enable contaminant migration to be mapped and direction of movement determined. This will indicate which perimeter borehole it is likely to intercept or indeed whether the existing spacing of perimeter boreholes is likely to be sufficient.
