Analysis of Bank Erosion on the Merced River, Yosemite Valley, Yosemite National Park, California, USA

MARY ANN MADEJ*
WILLIAM E. WEAVER¹
DANNY K. HAGANS¹

Redwood National Park
1125 16th Street
Arcata, California 95521, USA

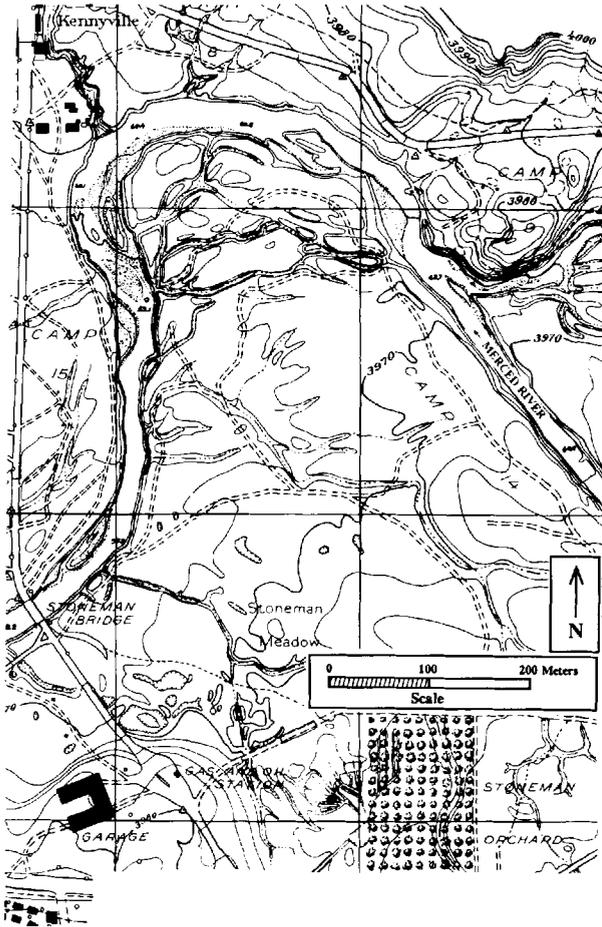
Figure 6. Reduced copy of 1919 USGS topographic map of Yosemite Valley and the Merced River. Two major bridges now present on the meander were not yet built. The original maps are at a 1:2400 scale, and they show well-defined channel boundaries, locations of ephemeral streams, roads, gravel bars, and spot channel bed elevations. Many small channels are shown on the sharp meander, whereas presently one greatly enlarged cutoff channel exists there.

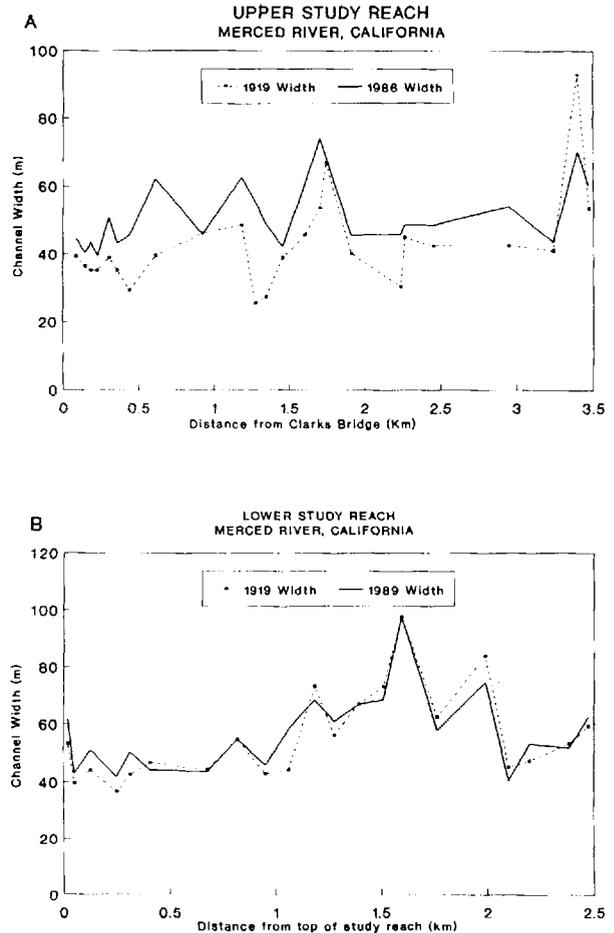
Results of channel width measurements show distinct differences between the upper and lower reaches (Figures 7A and B). In the upper reach (Figure 7A) channel widening occurred at 23 of the 24 cross sections. Channel widths increased up to 117%, and the average change in channel width was an increase of 27%. Sites with large channel width increases also had abundant field evidence of bank erosion, including trees and stumps presently located on the active channel bed, unvegetated banks, undercut banks, and bank collapse. The one cross section that was narrower in 1986 was a site where a mid-channel bar present in 1919 had become attached to the bank by deposition in the overflow channel at the base of the former right bank.

These results contrast sharply with measurements made in the lower reach (Figure 7B), where channel widths increased at only 10 of 21 cross sections, and the average change in channel width was an increase of 4%. In the upper reach, 39% of the banks showed active erosion, whereas in the lower reach only 17% of the banks displayed active erosion (Table 1).

Figure 7. Changes in channel width as measured from 1919 topographic maps and 1986–1989 field surveys. (A) Upper study reach; (B) lower study reach.

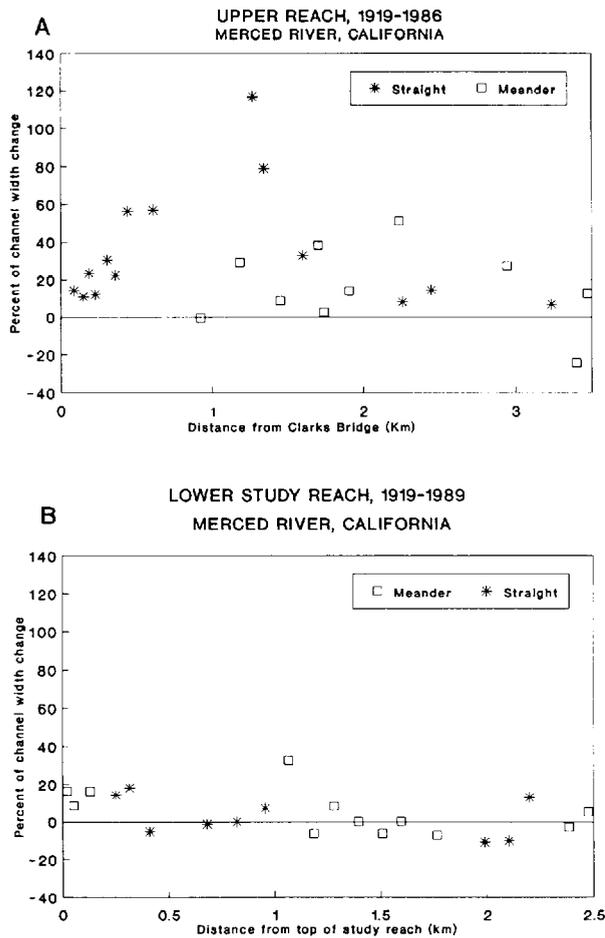
The upper reach of the Merced River differed from natural channel behavior in two major ways. First, streambank erosion was greater than deposition, resulting in a net increase in channel width. Second, streambanks eroded as commonly on straight stretches as on bends, and four of the five highest increases in channel width were in straight reaches (Figure 8A). In contrast, the largest channel width change in the lower reach occurred on a meander (Figure 8B).

Figure 8. Channel width changes in relationship to channel pattern. (A) Upper study reach; (B) lower study reach.

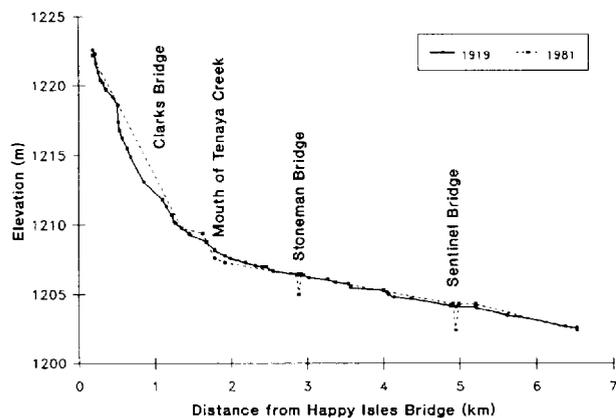
vice maps. Overlapping data sets were only available for the upper study reach. A comparison of the longitudinal profiles in the upper study reach in 1919 and 1981 showed little change in channel gradient through time (Figure 9). The apparent changes in the channel bed upstream of Clarks Bridge were probably an artifact caused by sparse survey points from the 1981 mapping. Downstream changes, in contrast, were probably real. The biggest differences were at two major bridges, Stoneman and Sentinel bridges,

where deep scour holes formed due to channel constriction caused by the bridges.

Figure 9. Comparison of 1919 and 1981 longitudinal profile surveys of the upper reach of the Merced River.

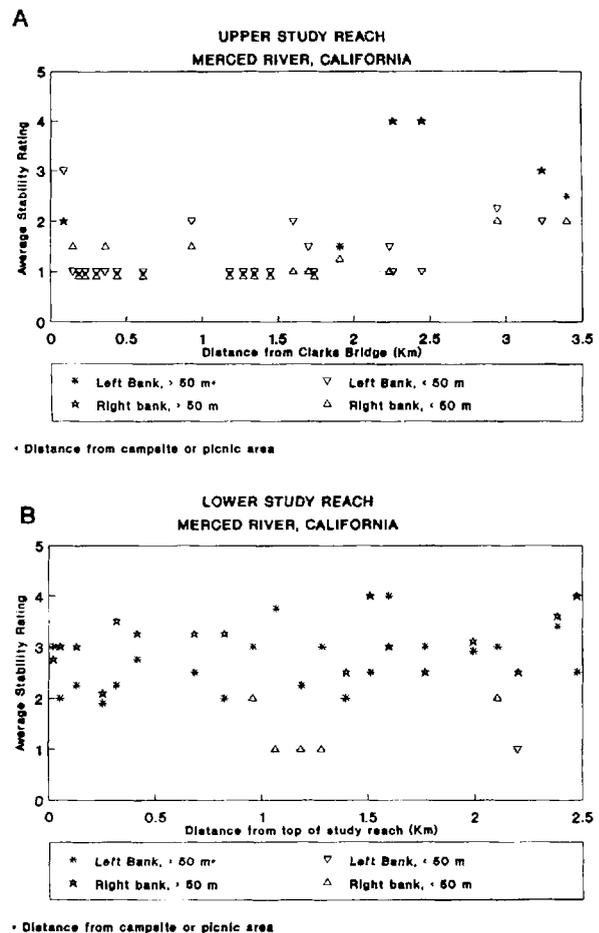
Figure 15. Streambank stability ratings versus intensity of visitor use in the upper and lower study reaches.

Figure 15 shows the strong association of low bank stability ratings with high use areas. In the upstream study reach, 95% of the banks that rated ≤ 2 were high use sites, and 80% of sites rating > 2 were low use sites. In the downstream study reach, 55% of the banks that rated ≤ 2 were high use sites, and 100% of sites rating > 2 were low use sites. Currently, high use areas have much less vegetative cover and more actively eroding banks than low use sites, and all sites with 0% vegetative cover were high use areas.

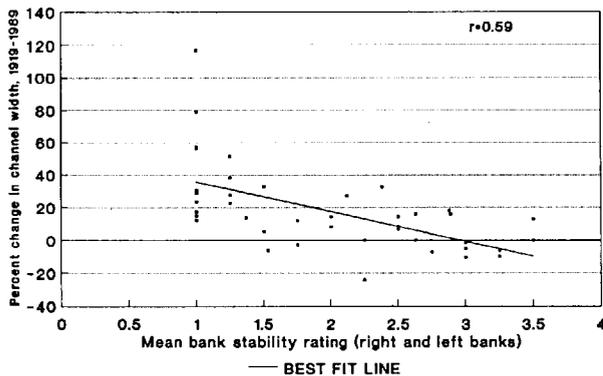
In addition, the degree of channel widening was compared with bank stability ratings (Figure 16). In this case, left and right bank ratings were averaged for an overall rating at a cross section. There is a general inverse relationship between the amount of channel widening since 1919 (percent increase or decrease in channel width) and bank stability ratings ($r = 0.59$).

Figure 16. Percent change in channel width versus mean bank stability ratings for the upper and lower study reaches combined.

Furthermore, *all* cross sections that exhibited more than a 20% increase in channel width were in high use areas.
